Tribocorrosion properties of metallic materials and effects of metal release

Ph. D. Thesis

August 2007

Department of Manufacturing Engineering and Management
Technical University of Denmark (DTU)
DK - 2800 Kgs. Lyngby.

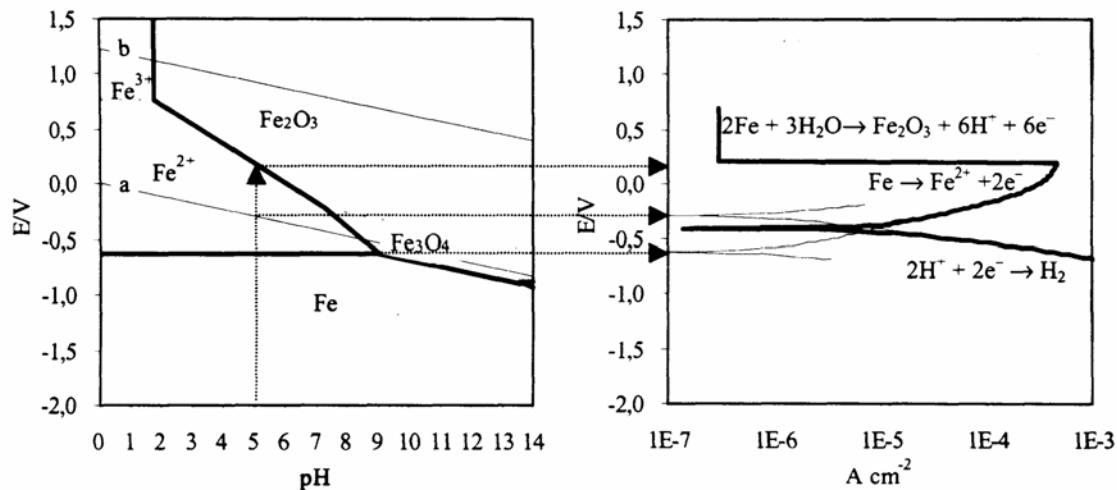
Figure 3.1 Pourbaix diagram for Fe with an activity of 10^{-6} and H_2 , O_2 activities = 1 (left) and a schematic polarization curve for iron (right). The curves for hydrogen ion reduction and iron oxidation are indicated together with the sum curve.⁶³

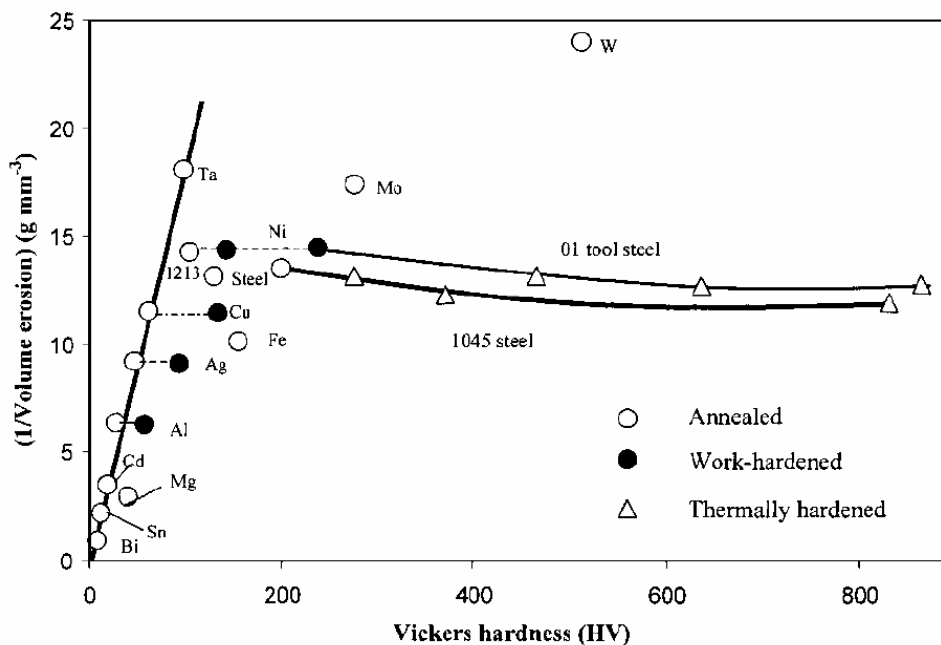
Figure 3.5. Erosion resistance as a function of hardness for massive metals and steels.⁸¹

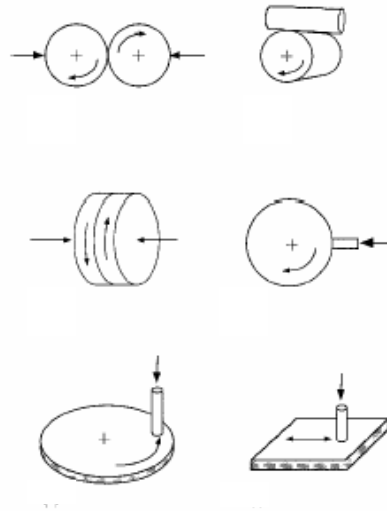
Figure 3.6 Illustration of common sliding wear test configurations.⁹³

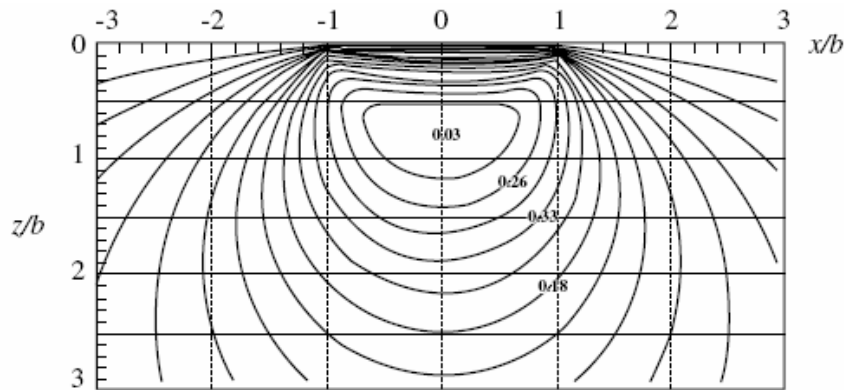
Figure 3.7 Contours of maximum shear stress normalized by Hertz stress beneath nominal line contact in a material with Poisson's ratio 0.3. The coordinates x and z are divided by the contact area b .⁹⁶

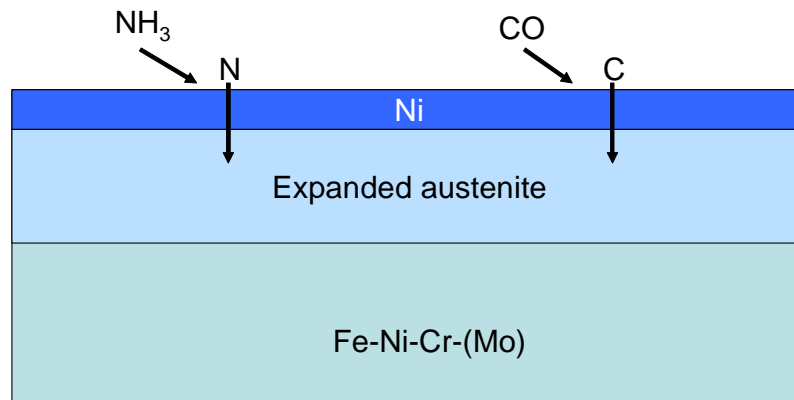
Figure 4.1 Schematic illustration of low temperature gaseous nitriding/carburising of stainless steel.

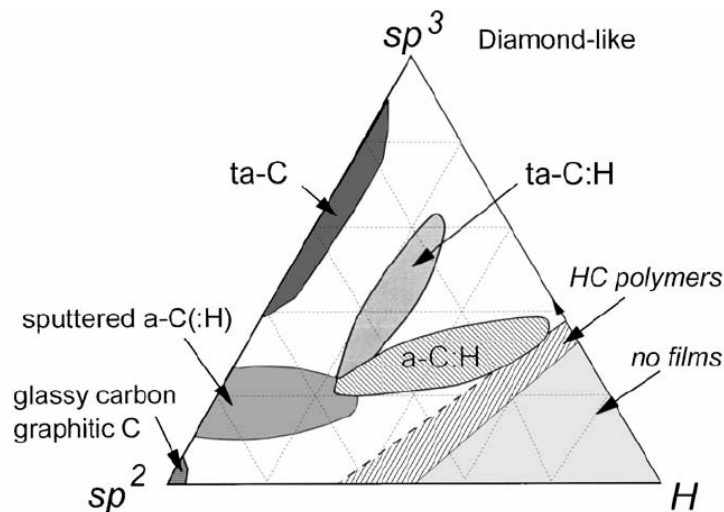
Figure 4.2 Ternary phase diagram showing the composition of various types of DLC systems.¹¹⁵

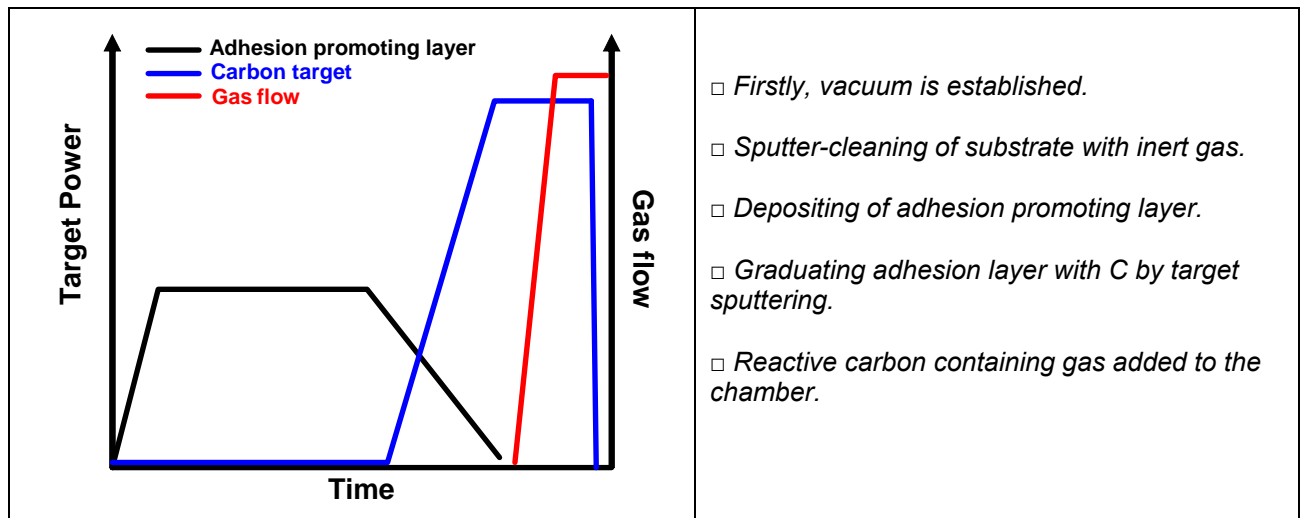
Figure 4.3 Typical depositing process of DLC.

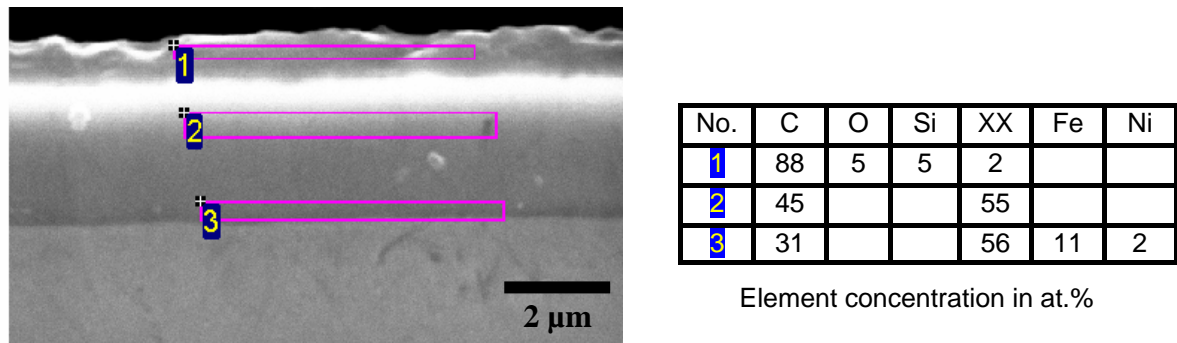
Figure 4.4 SEM image with EDS analysis of DLC coated AISI 316 L.

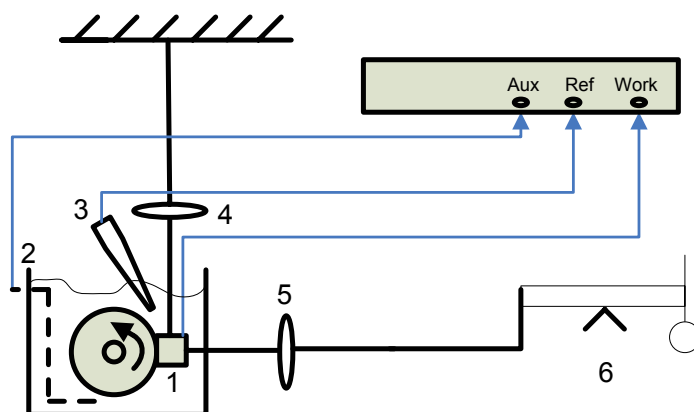
Figure 5.1 Schematic view of the block-on-ring tribocorrosion testing facility. 1. Working electrode, 2. Auxiliary electrode, 3. Reference electrode, 4. Strain gauge (Ft), 5. Strain gauge (Fn), 6. Weight load system.

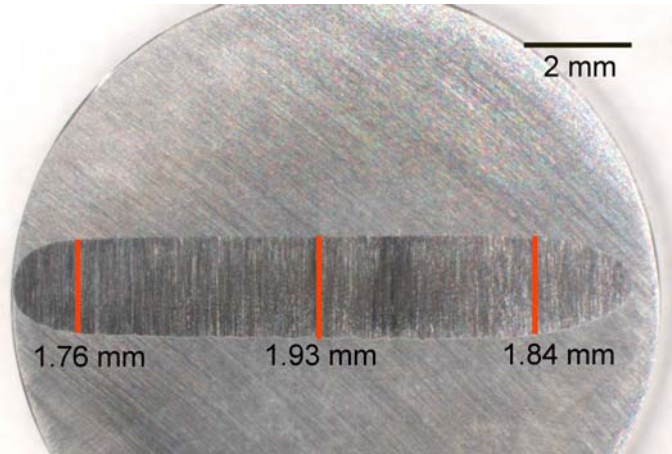
Figure 5.2 A typical wear track on stainless steel AISI 316 L after sliding against an alumina ring in dilute sulphuric acid at 15-20 N for 43 minutes.

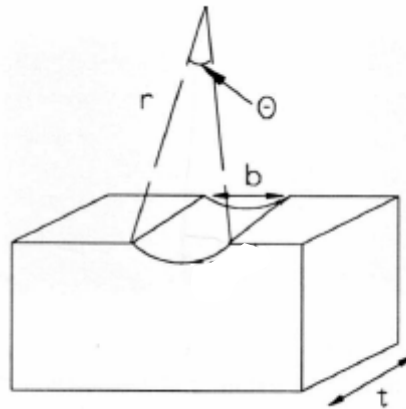
Figure 5.3 Volume loss assessment.

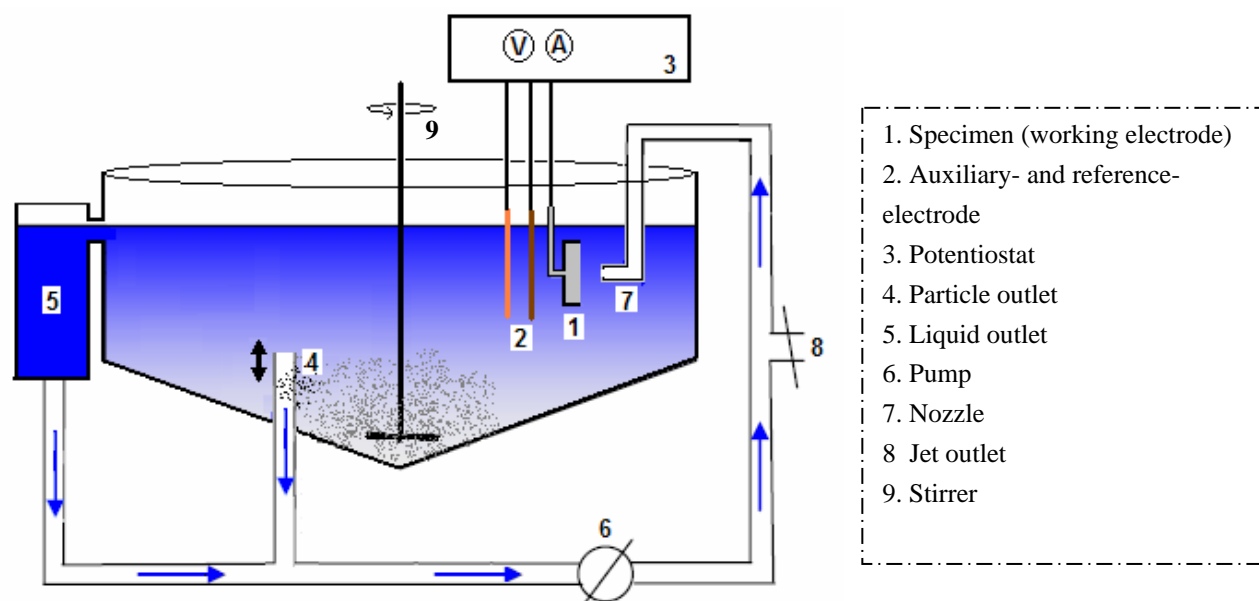
Figure 5.4 Erosion-corrosion test setup.

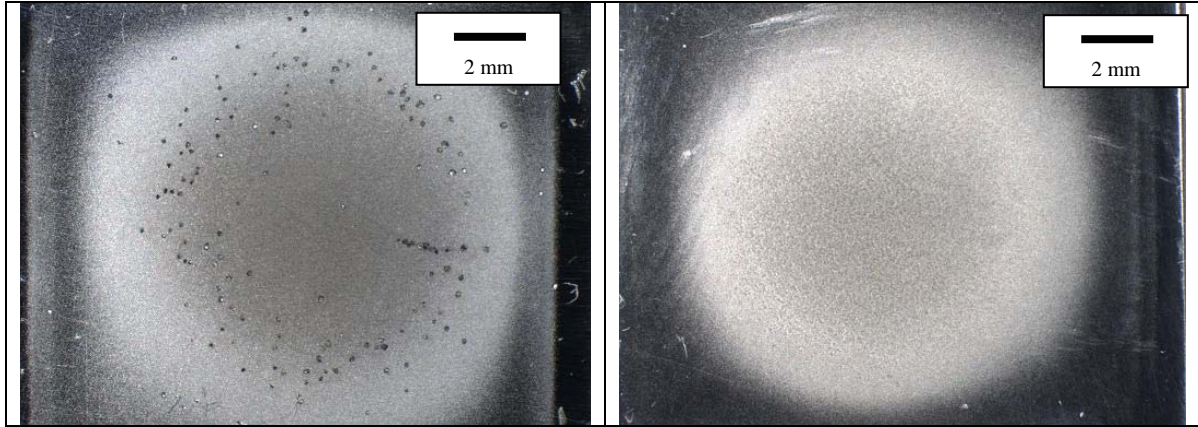
Figure 5.5 A typical wear track after erosion-corrosion of untreated AISI 316 L (left) and low temperature nitrided AISI 316 L (right). Exposure conditions 0,03 % chloride in 0,1 M natriumacetate buffer at pH 5,5 with 5,6 g/l alumina particles size 250 μm for 120 min and then the specimens were polarized to 1744 mV SHE.¹²³

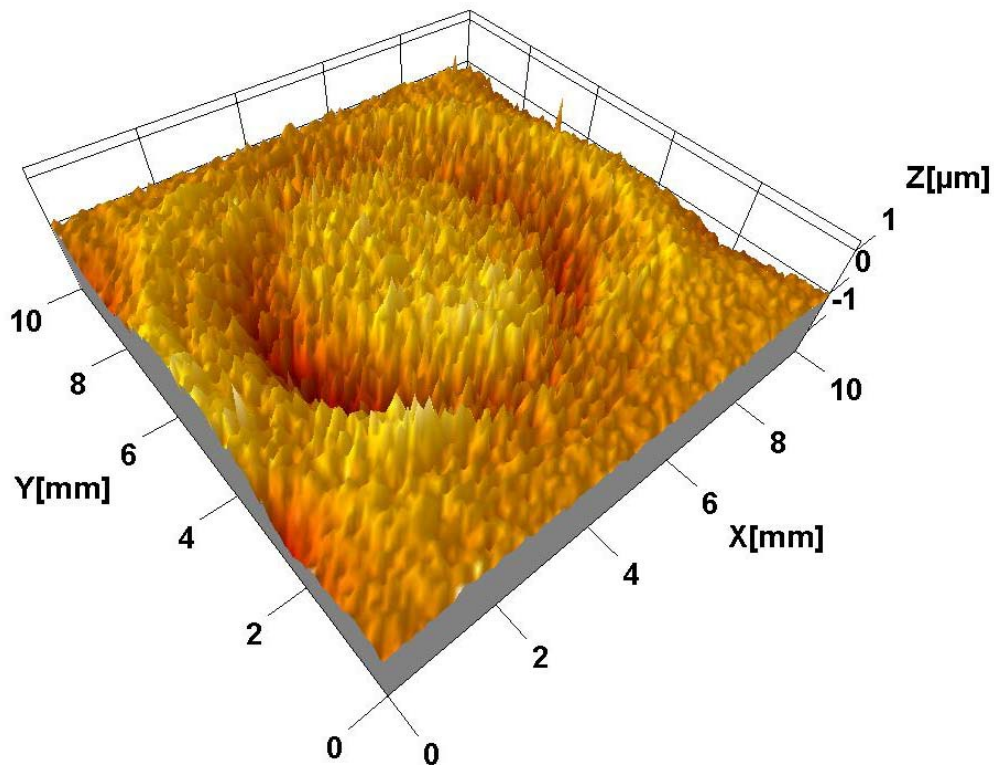
5.6 Surface topography made by nondestructive laser measurement of DLC-coated AISI 316 L after erosion-corrosion in 0.05 M sodium citrate/citric acid buffer at pH 4 with a sodium chloride concentration of 0.5 wt.% and 0.5 g/l, 250 μm alumina particles.

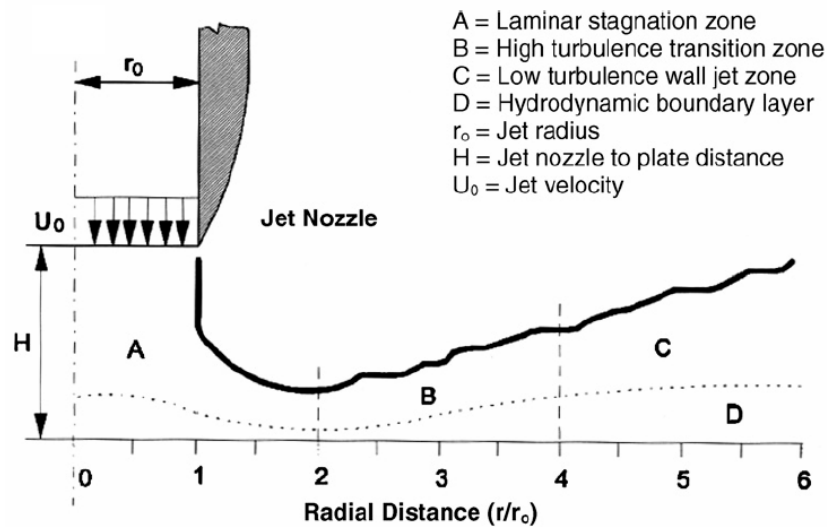
Figure 5.7 Hydrodynamic characteristics of a jet impinging on a flat plate.¹²⁴

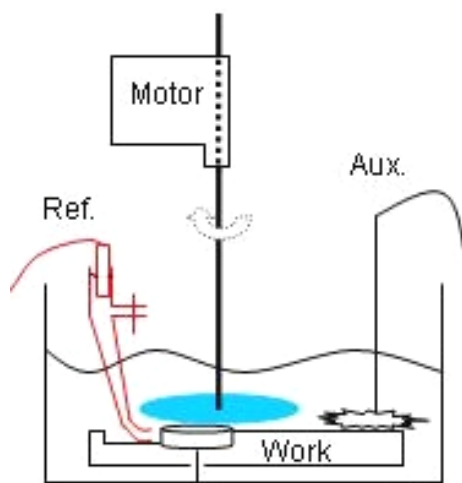
Figure 5.8 Tribocorrosion apparatus for investigating mild rubbing wear.

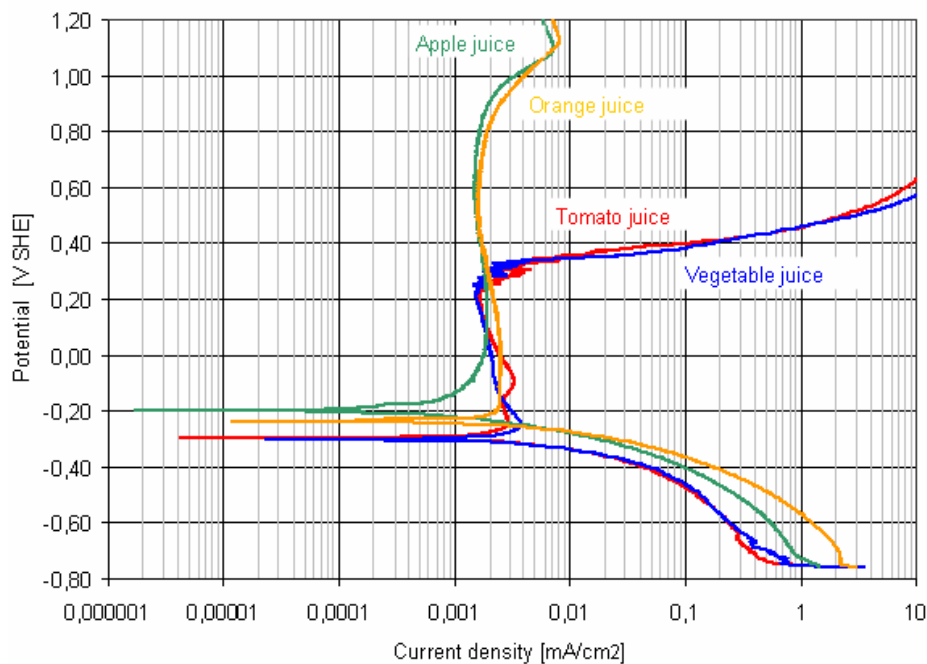
Figure 6.1 Polarization curves for AISI 304 at 30 °C in orange, apple, tomato and vegetable juice at a scan rate of 10 mV/min.

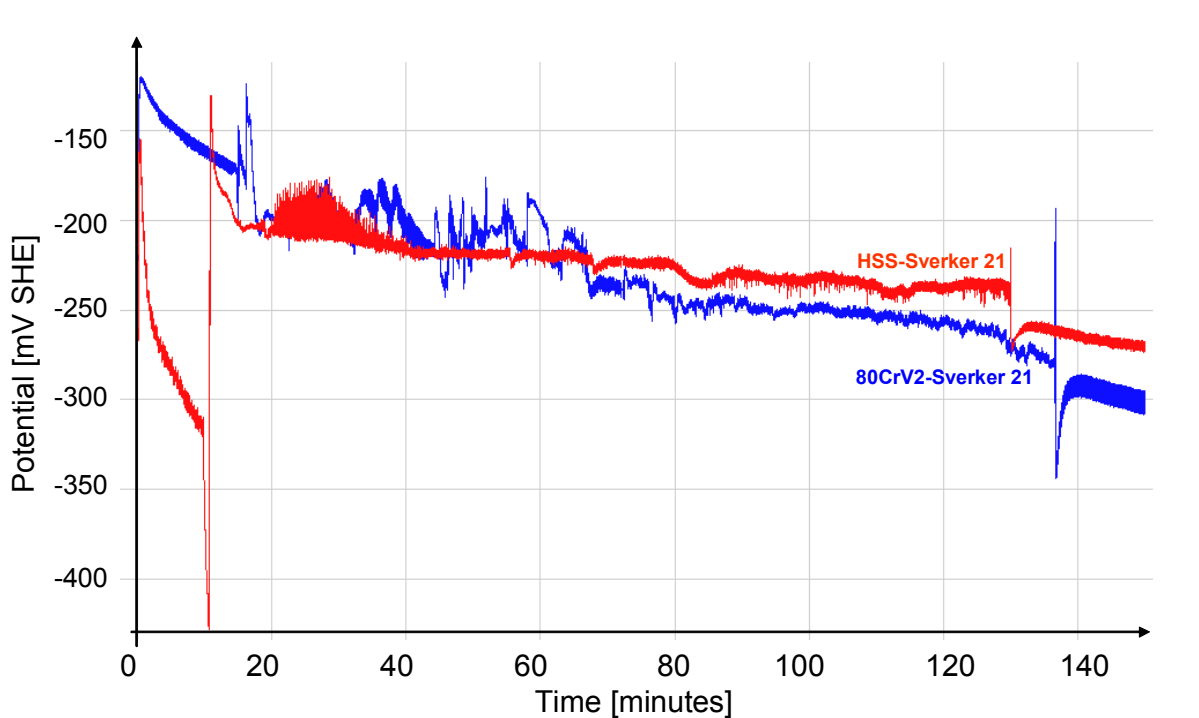
Figure 6.2 Open circuit potential monitoring of HSS block - Sverker 21 ring and 80CrV2 block - Sverker 21 ring couplings in aqueous solution of 0,21 wt.% chloride.

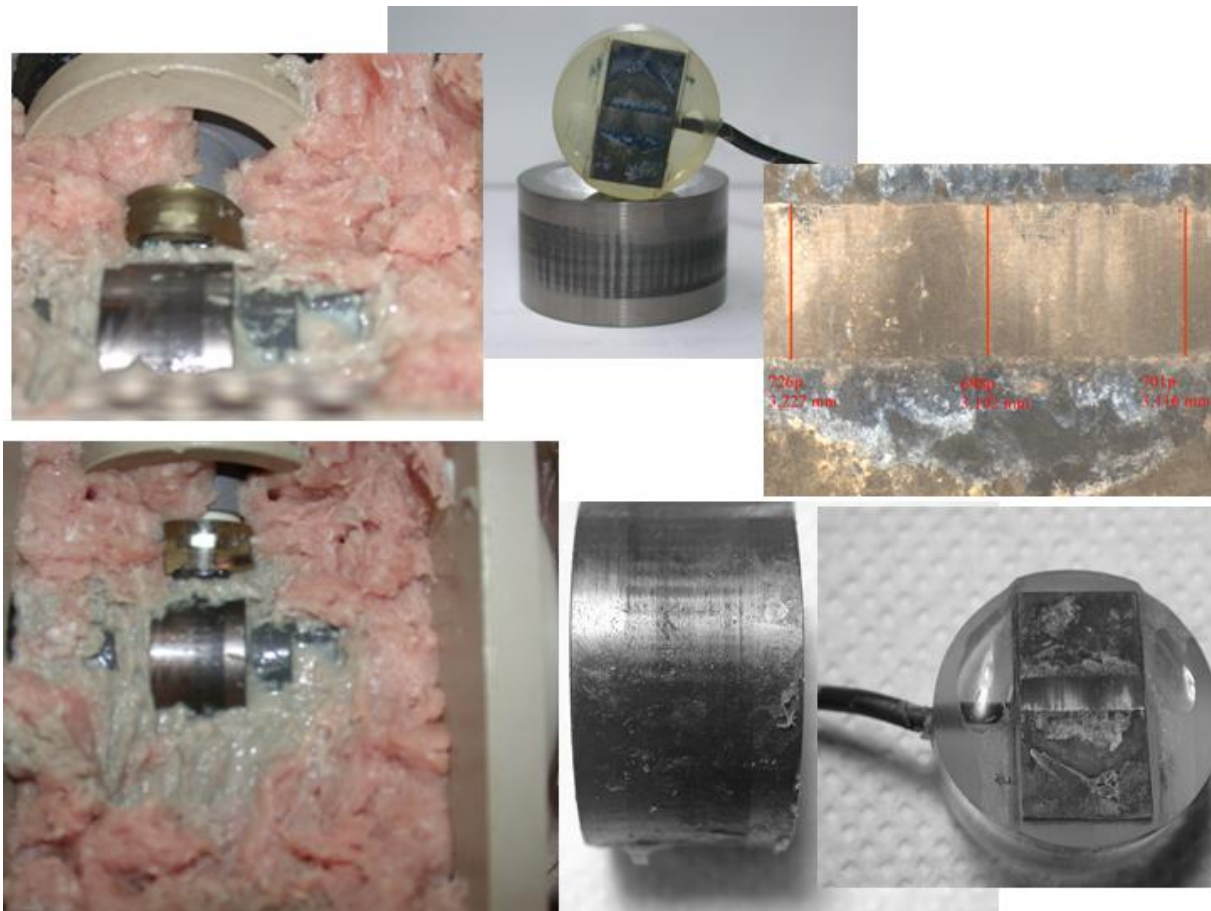
Figure 6.3 A 80CrV2 block after sliding against Vancron 40 ring in minced meat, after removal of the top layer of minced meat.

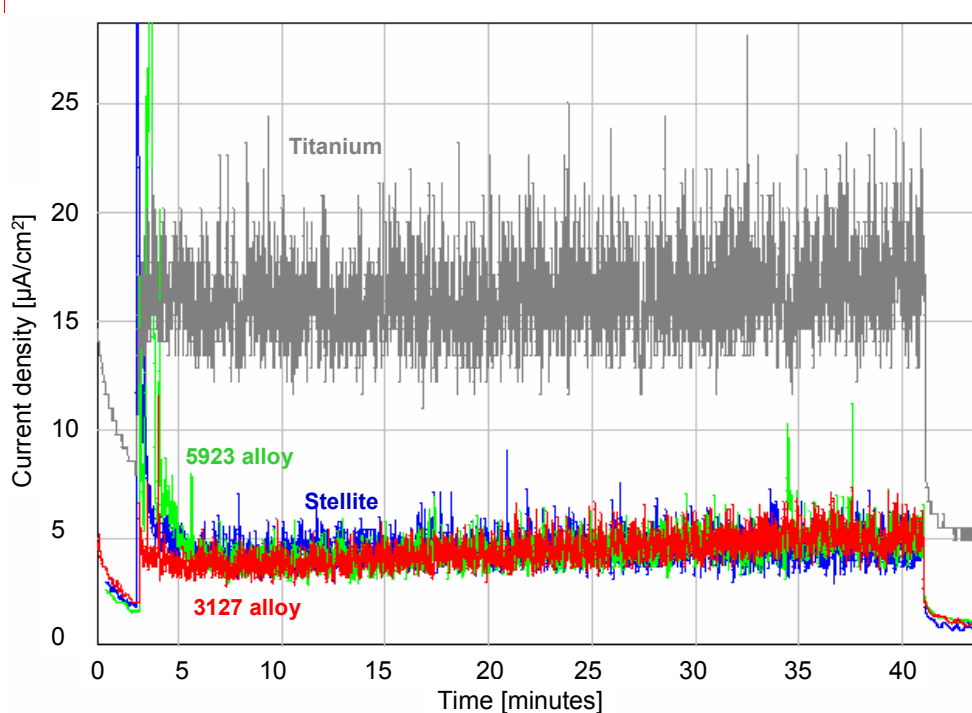
Figure 6.4 Chronoamperometry at 644 mV SHE, eroded with 0,6 g Al_2O_3/l , size 250 μm , 0,5 wt.% NaCl at pH 4 for 38 minutes.

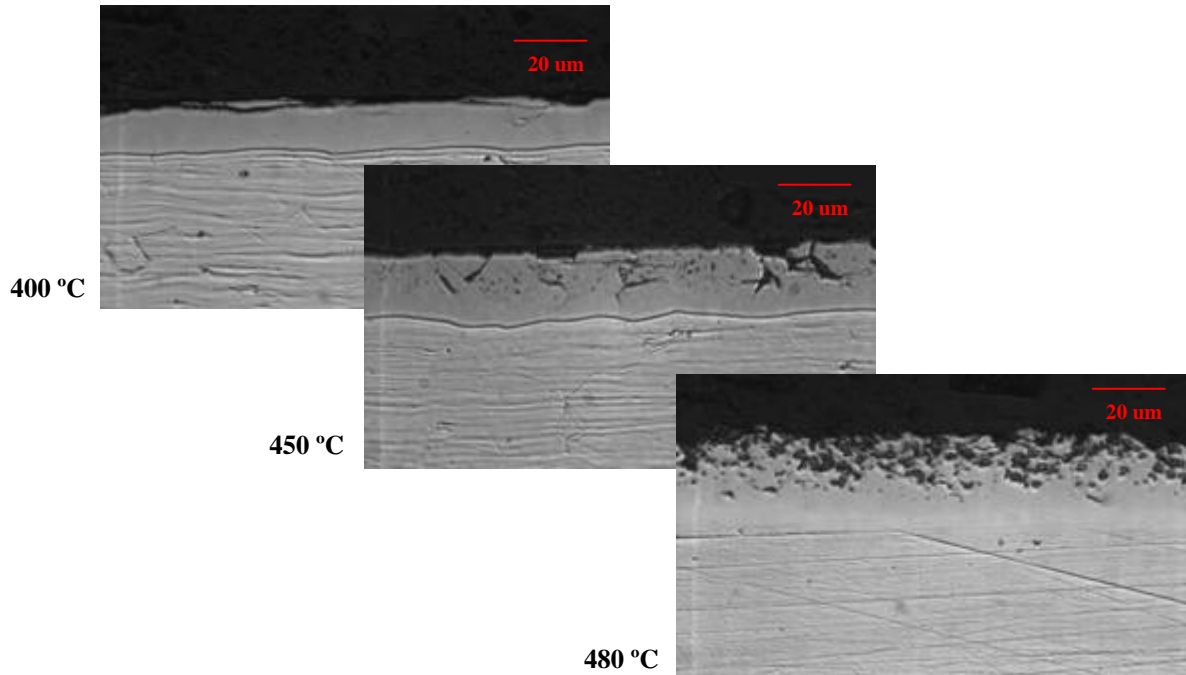
Figure 6.5 Micrographs of plasmanitrided steel at 400 °C for 60 hours, 450 °C for 30 hours and 480 °C for 18 hours, all etched with Kahlings reagent. Precipitation of nitrides has clearly occurred for the 480 °C treatment appearing as black areas.

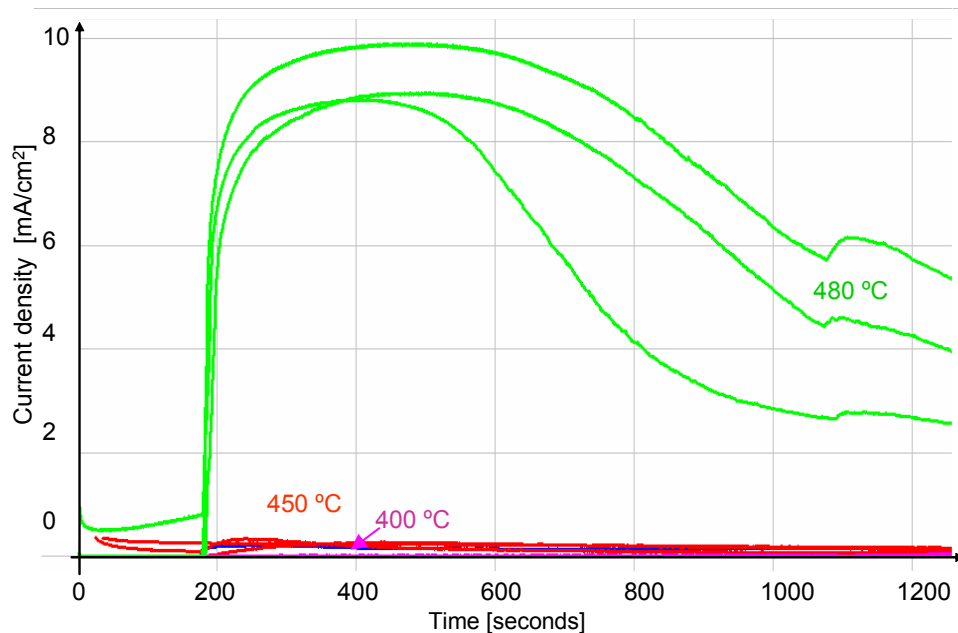
Figure 6.6 Chronoamperometry of plasmanitrided samples (3 repetitions for each temperature) at 644 mV SHE, eroded with 0,6 g $\text{Al}_2\text{O}_3/\text{l}$ size 250 μm , 0,5 wt.% NaCl at pH 4 for 18 minutes.

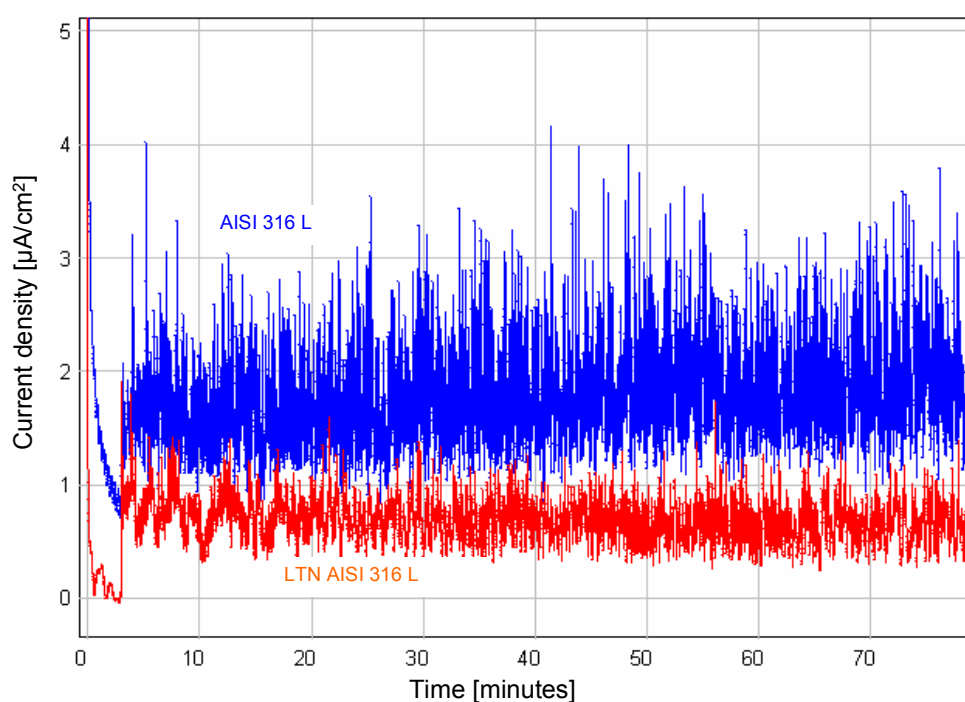
Figure 6.7 Erosion-corrosion of untreated and low temperature nitrided stainless steel at a fixed potential of 644 mV SHE, eroded by 0,6 g/l Al_2O_3 size 250 μm particles in 0,5 wt.% NaCl solution buffered to pH 4.

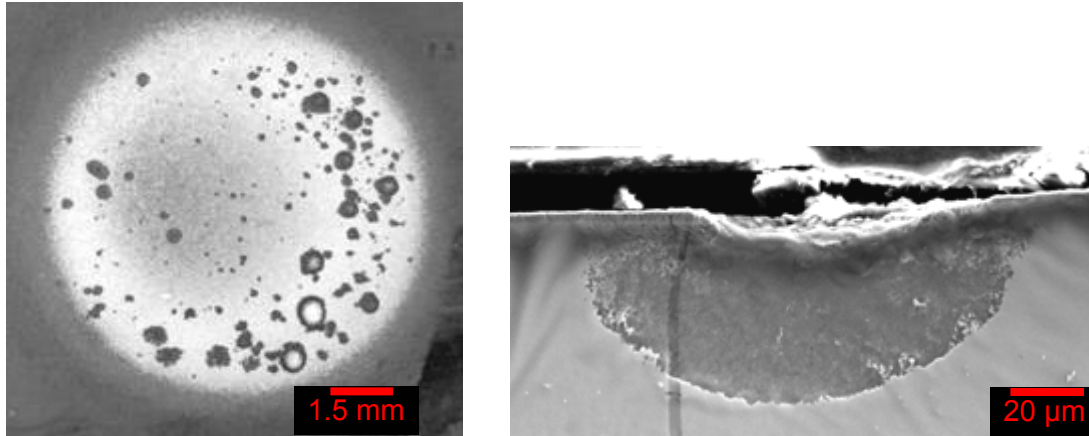
Figure 6.8 Duplex-DLC after erosion-corrosion testing indicating severe local corrosion of the plasmanitrided zone, beneath the DLC layer.

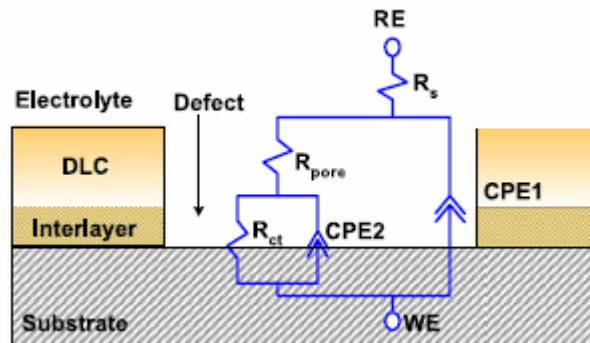
Figure 6.9 Equivalent circuit for investigating DLC and DLC-duplex coatings on stainless steel.¹³²

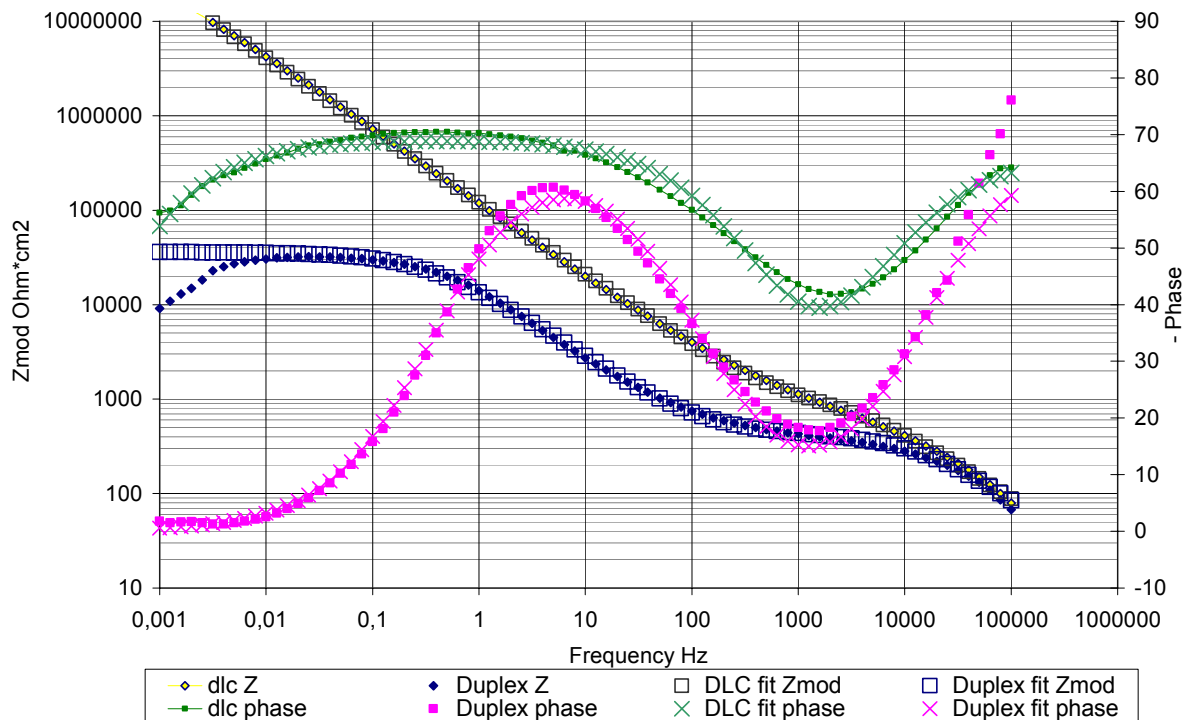
Figure 6.10 EIS Bode plot for DLC and DLC-duplex ranging from 1 mHz to 1 MHz.

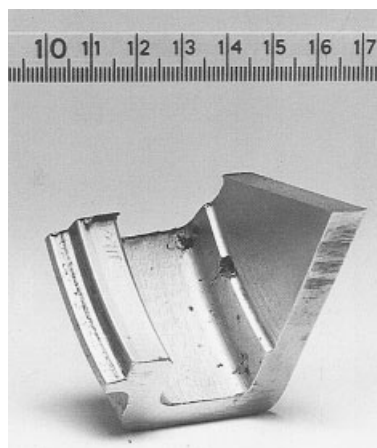
Fig. 1. Part of a cast pump casing (AISI 316) used in a ketchup plant. Pitting corrosion due to high chloride content has caused failure in 6 months [19]

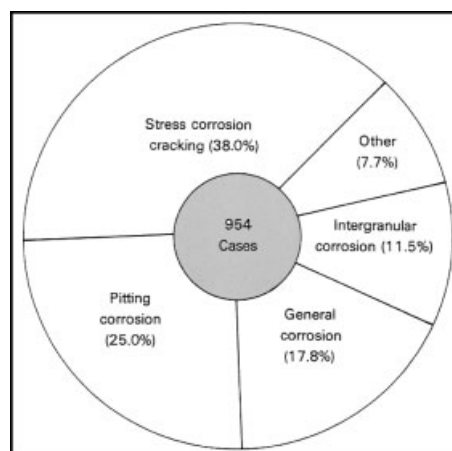
Fig. 2. Summation of causes of failures of stainless steel investigated by a large chemical company in the U.S. [20]

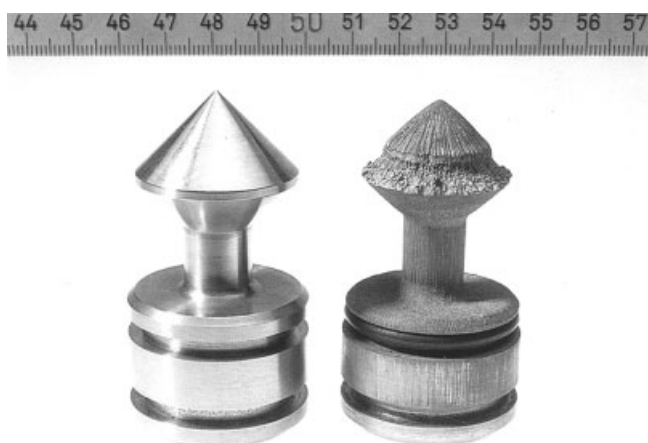
Fig. 3. Back-pressure control valve (Monel) of the mixing chamber of the pump of a margarine cooler. An unused specimen is shown to the left and a severely attacked specimen to the right. Erosion-corrosion is caused by the salt-containing margarine combined with high local velocity [19]

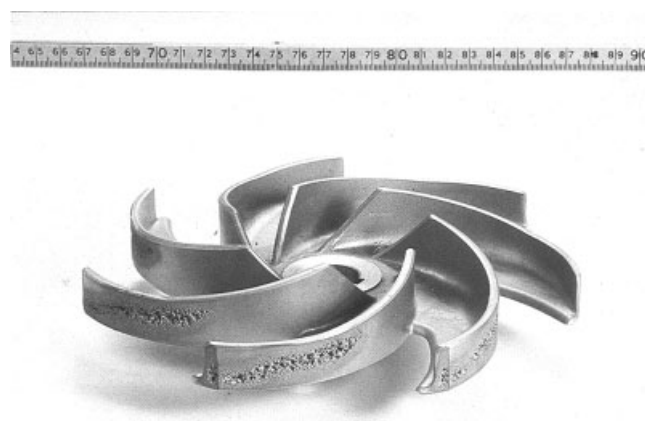
Fig. 4. Pump impeller (AISI 316) from a vacuum evaporation system for milk powder manufacture. Material is worn away locally after 1 year of use [19]

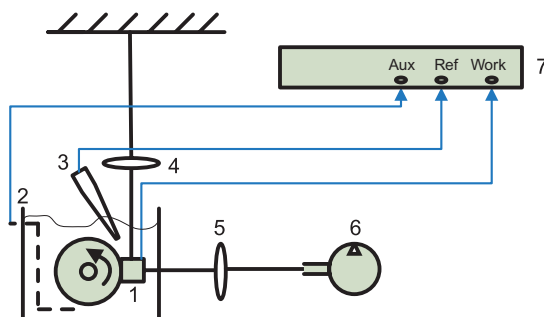
Figure 2. Schematic view of the tribocorrosion setup. 1. Working electrode, 2. Auxiliary electrode, 3. Reference electrode, 4. Strain gauge (F_t), 5. Strain gauge (F_n), 6. Air supply, 7. Potentiostat

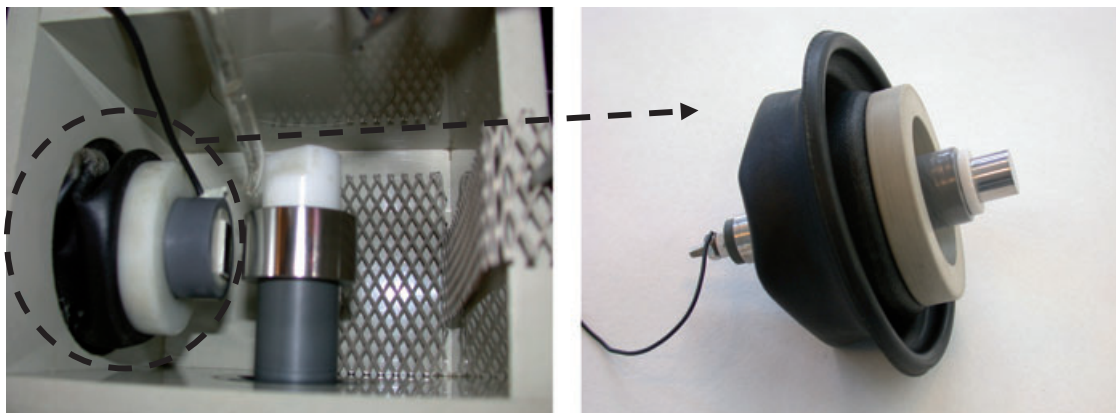
Figure 3. Electrochemical measurements using a standard three-electrode setup in a box, seen from above (to the left). A standard calomel electrode serves as a reference electrode and a net of titanium as counter electrode. The ring shown in this picture is a metallic ring. The working electrode holder used for cylindrical blocks is shown to the right

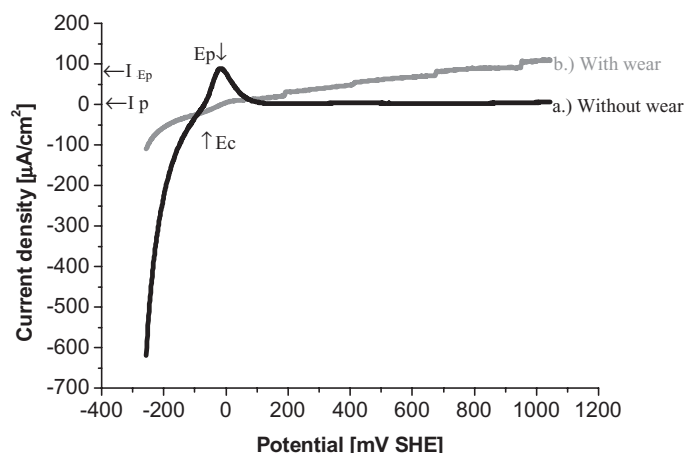
Figure 4. Results from experiment 1a and 1b showing polarization curves of stainless steel 3161 in 0.5 M sulphuric acid with and without wear. The potential scan is ranging from -244 to 1044 mV SHE at a scan rate of 0.5 mV/s

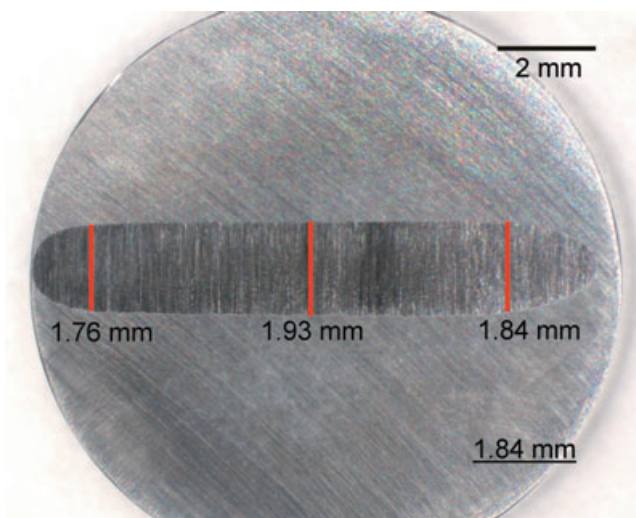
Figure 5. A typical wear track shown for a block used to establish a polarization curve with wear. The average wear track width is given as 1.84 mm (underlined)

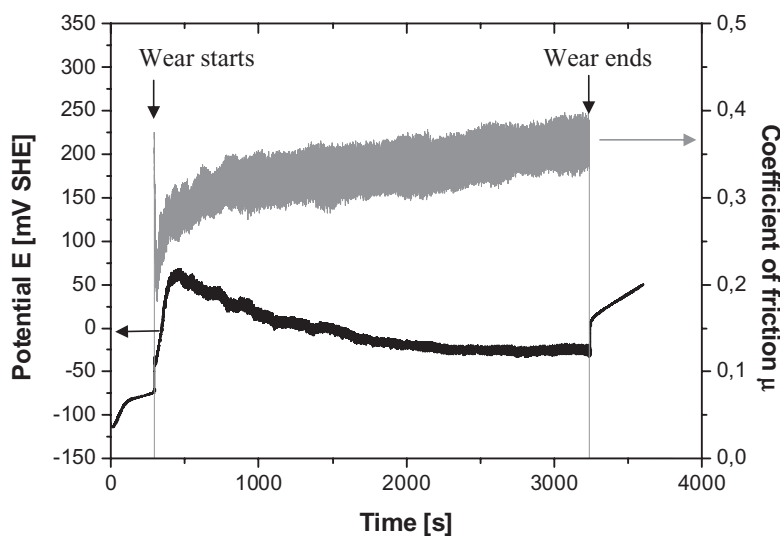
Figure 6. Results from experiment 2 showing how wear influences the OCP. The most representative curve of three repetitions is shown

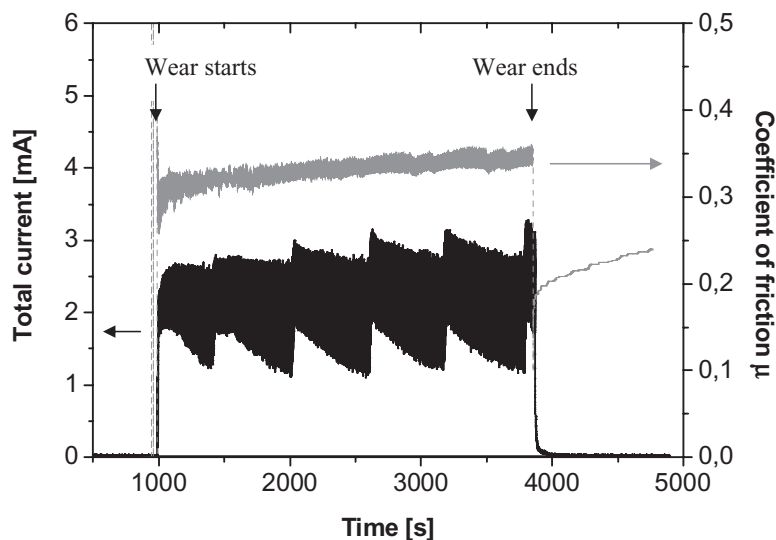
Figure 7. Results from experiment 3 showing the total current and coefficient of friction at an applied potential of 744 mV SHE. The most representative curve out of three repetitions is shown

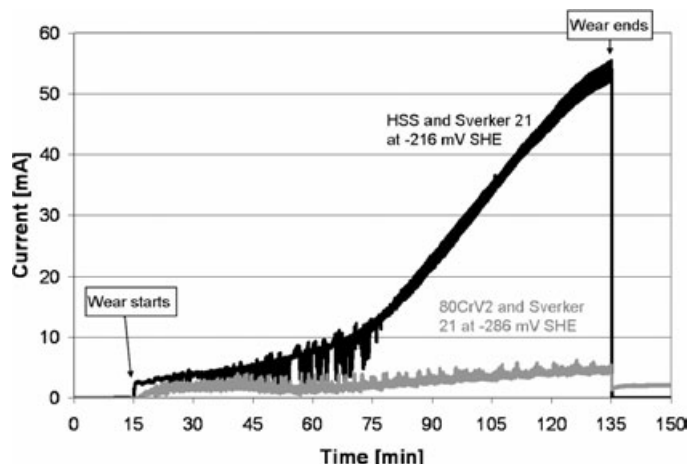
Figure 8. Chronoamperometry of 80CrV2 and HSS against Sverker 21 at 55–65 N load in an electrolyte containing 0.21% chloride adjusted to pH 5.6 with lactic acid. Wear duration is 120 minutes

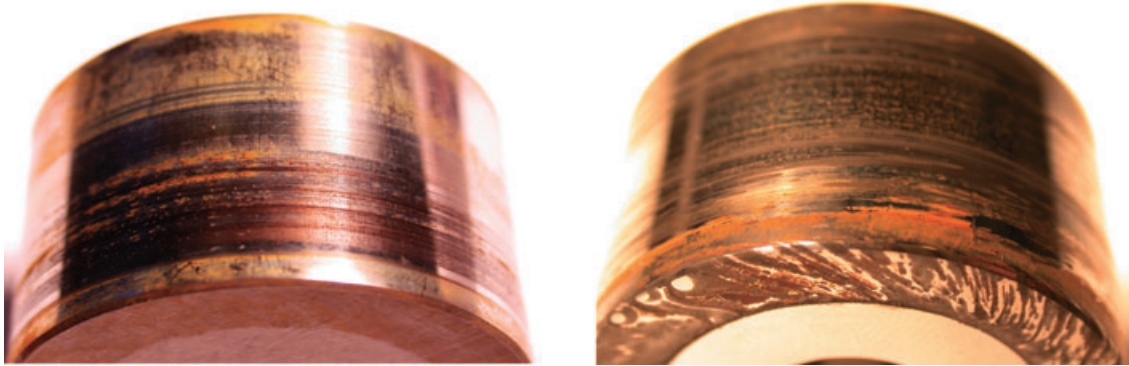
Figure 9. Sverker 21 (ø35 mm) rings after a chronoamperometry study. To the left, a ring after wear against 80CrV2, and to the right, after wear against HSS

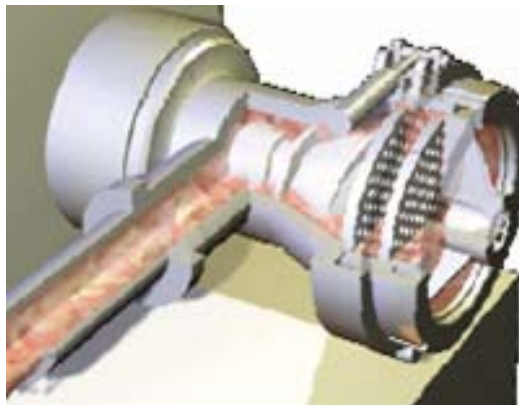
FIG. 1. A TYPICAL SETUP USED FOR MEAT MINCING
IN A CABINET WITH A CONVEYOR SCREW AND
PERFORATED DISCS WITH KNIVES

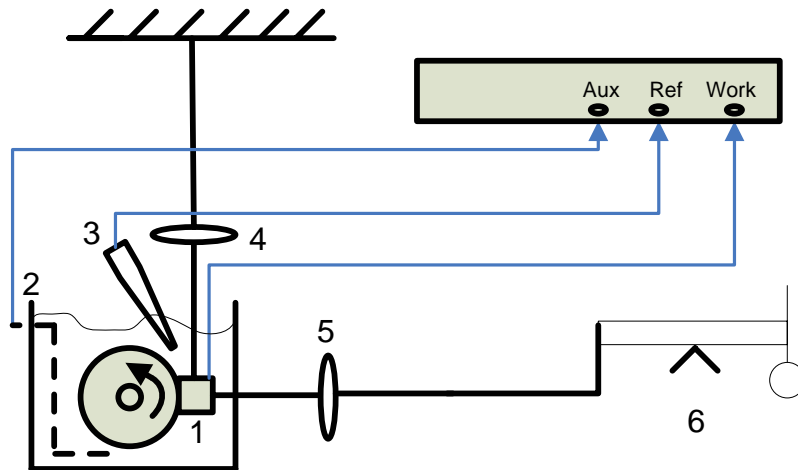
FIG. 2. SCHEMATIC VIEW OF THE TRIBOCORROSION SETUP. 1. Working electrode, 2. Auxiliary electrode, 3. Reference electrode, 4. Strain gauge (F_t), 5. Strain gauge (F_n), 6. Weight load system.

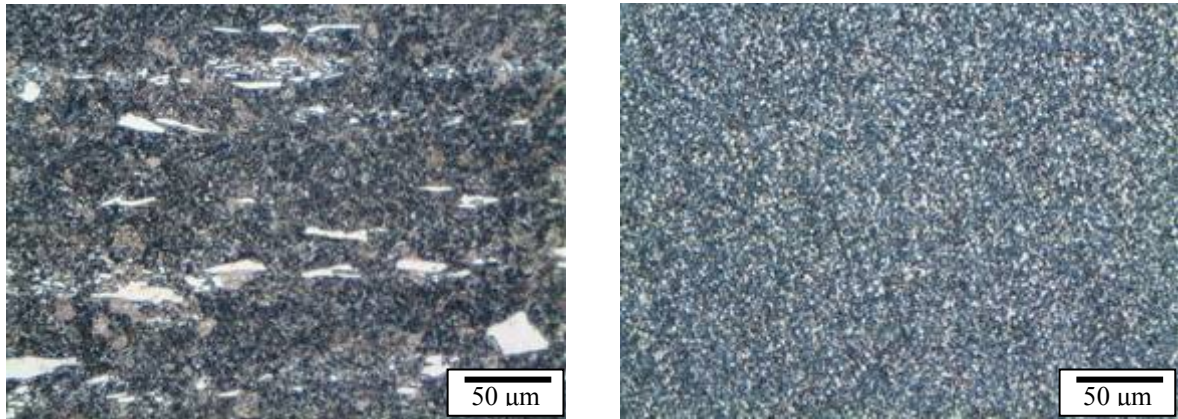
FIG. 3. MICROGRAPHS OF SVERKER (LEFT) AND VANCRON (RIGHT) ETCHED WITH 5 % NITAL SHOWS THE SIZE AND DISTRIBUTION OF HARD PHASES (WHITE)

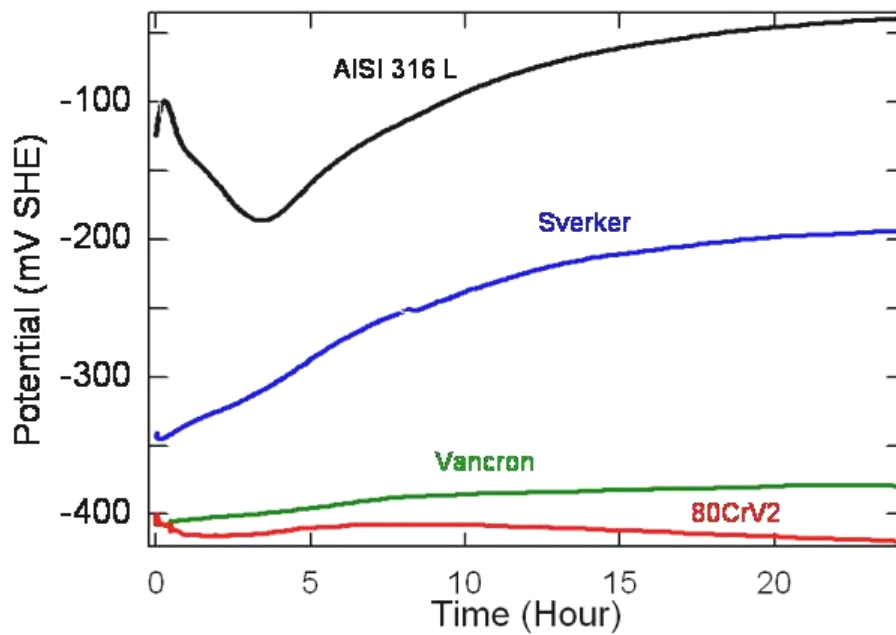
FIG. 4. OPEN CIRCUIT POTENTIAL 24 MONITORING IN MINCED MEAT ADDED 0.21 WT.% CHLORIDE

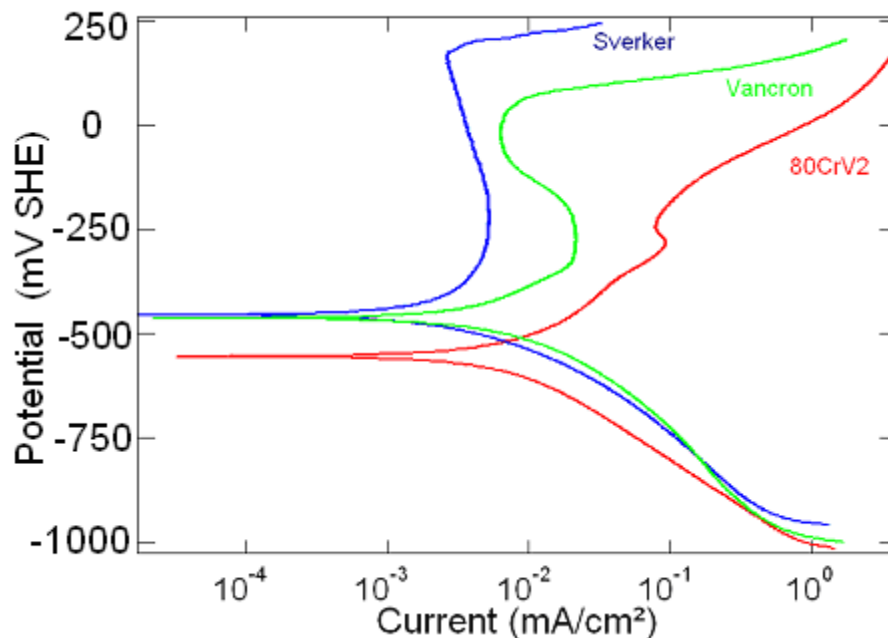
FIG. 5. POLARIZATION CURVES IN MINCED MEAT ADDED 0.21 WT.% CHLORIDE, PERFORMED AT ROOM TEMPERATURE WITH A SCAN RATE OF 30 mV/MIN.

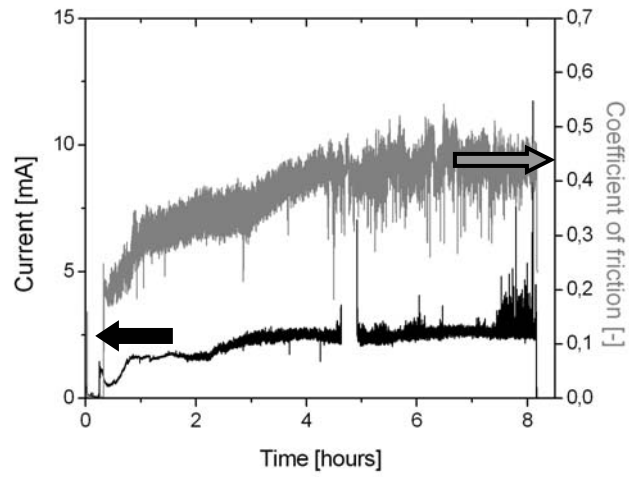
i.) Sverker ring against 80CrV2 block

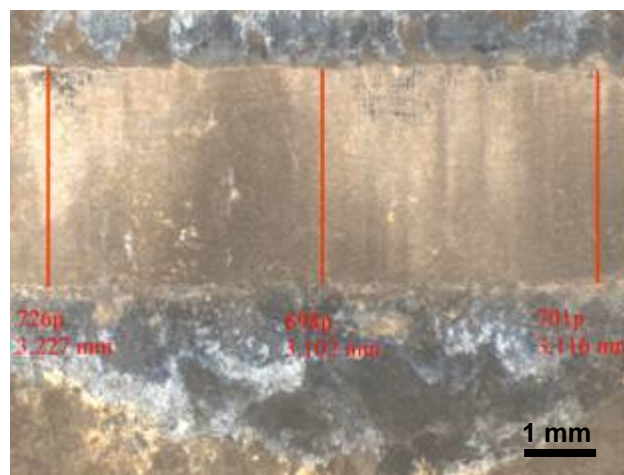
FIG. 7. WEAR TRACK ON 80CrV2 AFTER SLIDING AGAINST VANCRON IN
MINCED MEAT ADDED 0.21 WT.% CHLORIDE WITH A 2 KG LOAD AT - 156 mV
SHE

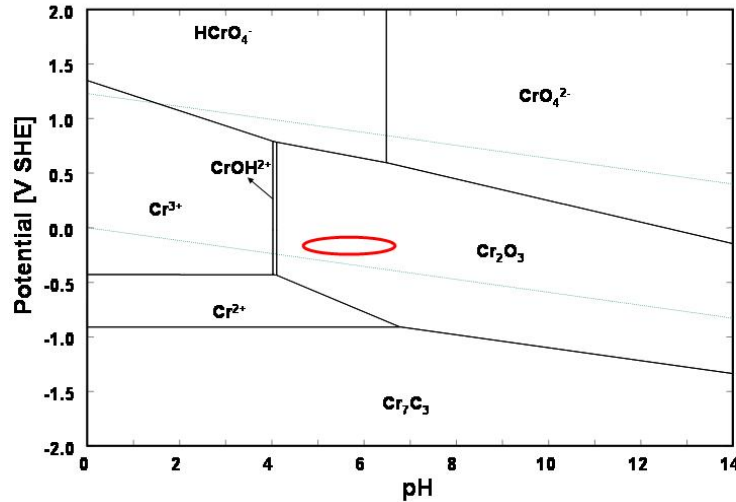
FIG. 9. POURBAIX DIAGRAM FOR Cr_7C_3 AT $1 \cdot 10^{-6} \text{ M Cr}$ AND $1 \cdot 10^{-3} \text{ M C}$ AT 1 BAR AND 25°C

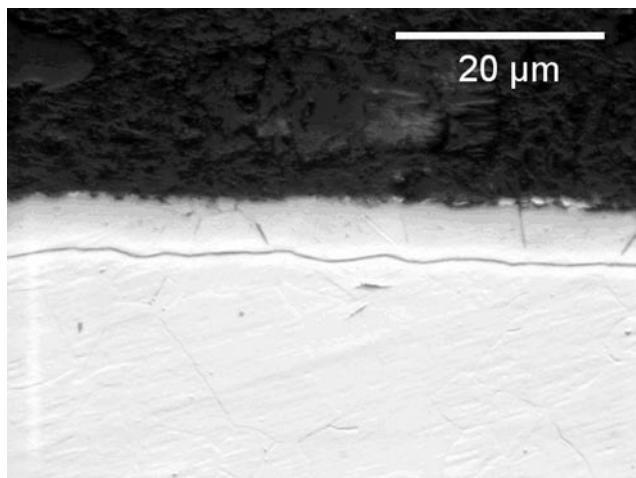
Figure 2—Light optical microscopy picture of the cross section of low temperature nitrided stainless steel. The cracks in the layer can be caused by the preparation, due to the brittleness of the layer. The surface was polished to 1- μm finish and was etched with HCl/HNO_3 solution for 30 sec.
